An Unusual Abdominal X-ray

Mugurel-Costel Apetrii, Michel Tintillier, Charles Cuvelier, Jean-Michel Pochet

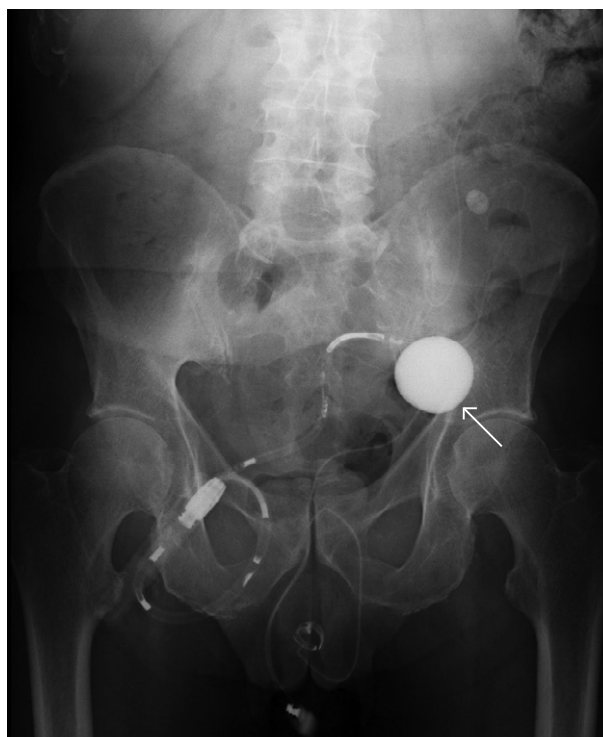
Panel A. Plain abdominal radiography shows migration of the catheter tip in the left flank. A central opacity (arrow) can also be seen.

Two weeks later, an attempt to infuse dialysis fluid via the peritoneal dialysis catheter was made unsuccessfully, and a catheter flow obstruction was observed. Plain abdominal radiography showed migration of the tip of the catheter in the left flank; a central opacity was also noted (Panel A).

Further questioning of the patient revealed that the round opacity within the image was a silicone abdominal reservoir of a urinary sphincter prosthesis (AMS 800; American Medical Systems Inc., Minnetonka, MN, USA).

Catheter flow obstruction is a common cause of technical failure. It usually occurs as a result of catheter migration, omental or small bowel entrapment, or fibrin clots [2]. In this case, there was migration of the tip of the catheter in the left flank, and in the interior, radio-opaque contrast residue could be seen.
